## Car Carrier Report

**Purpose of installation:** Efficiency test of the HydroPath Marine Technology.

**Application:** Fresh Water Generator, Main cooling system

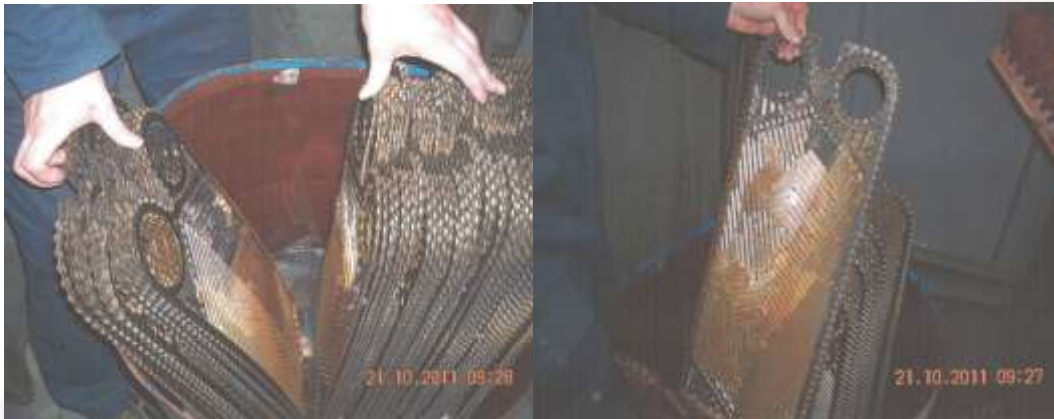
Figure 1. FWG before – October 2011

**Installation description:** HydroPath Marine HM120 was installed on a 4" pipe, feeding seawater to the FWG. The FWG was opened and cleaned approx. 2 weeks prior to installation and was documented as seen on figure 1.

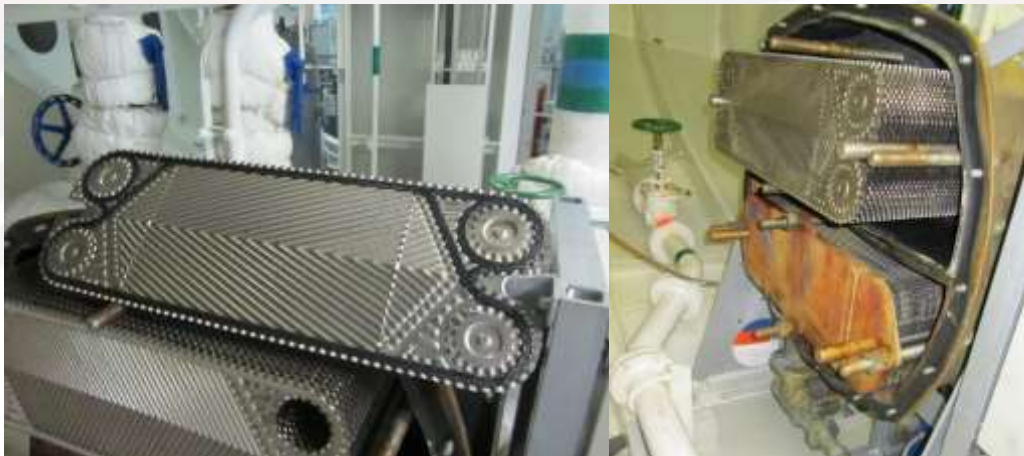
Figure 2. FWG after – August 2012

**Findings:** The FWG was opened on August 2012. There were no traces of slime and mad. At the front part of the plates there was no limescale but further inside there was some limescale which was easily removed by hand and without chemicals. The entire process of opening and cleaning of the FWG took only 2-3 hours. Without HydroPath Marine, the opening process can take up to 24 hours due to the soaking time of the plates in chemicals to dissolve the limescale.

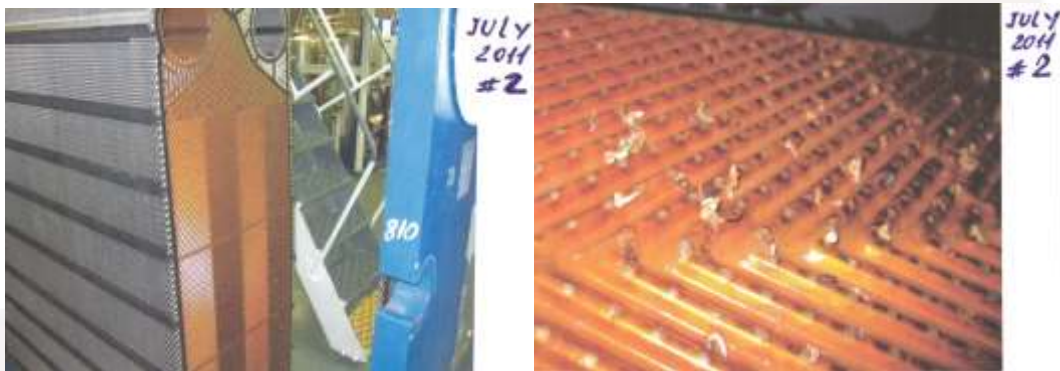
Figure 3. Main Cooling System before – July 2011

**Findings:** The Main Cooling System #2 was opened on July 2011. The plates contained large amount of barnacles that are the main factor of water flow reduction which affects the cooling efficiency. The Main Cooling System #2 was opened again on August 2012. The plates were clean from limescale or barnacles. A thin layer of slime covered the plates and was easily washed away.

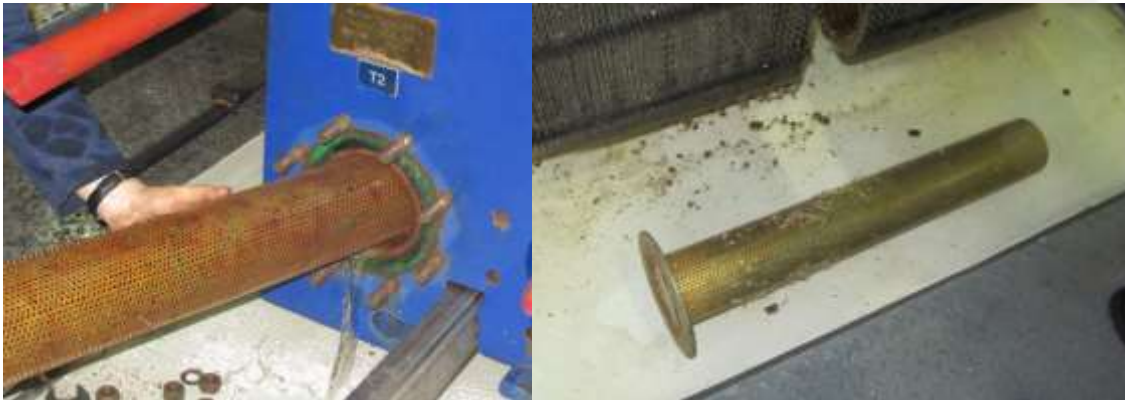
Figure 5. Particles filter after – August 2012

The particles filter at the bottom of the unit was also found clean of barnacles and was easily washed. This filter is usually covered with barnacles strongly attached to it, and removing them requires manual scrubbing that damages the filter.
