Third-Party Technology Verification of the Hydropath Technology at the J. B. Messerly Water Pollution Control Plant, Augusta, Georgia.

PREPARED FOR: Tal Journo/*HydroFLOW* USA LLC (*HydroFLOW* USA)
PREPARED BY: Samuel Jeyanayagam, PhD, PE, WEF Fellow/Jacobs (Jacobs)
DATE: November 5, 2018

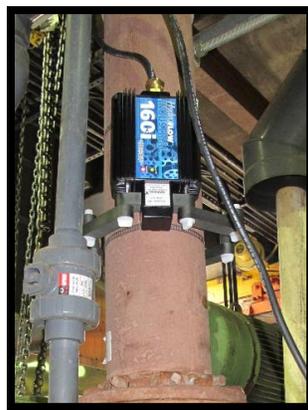
The *HydroFLOW* I Range is powered by the patented Hydropath technology. When properly installed on a pipe (see Figure 1), it induces a 150 kilohertz, oscillating sine wave, alternating current (AC) signal. The electric induction is performed by a special transducer connected to a ring of ferrites. The pipe and the flowing fluid act as a conduit, which allows the signal to propagate. The induced AC signal is believed to cause the mineral ions that make up struvite (magnesium, ammonium, and phosphate) to form loosely held together clusters. When certain conditions are created (e.g., pressure change, temperature change, and turbulence) the clusters precipitate out of solution and form stable crystals of struvite that remain in suspension. The crystals are not able to adhere to surfaces as hard scale and are carried away with the flow. Because hard scale no longer accumulates, the shear forces created by the flowing liquid erode and soften existing scale deposits over time. It is important to note that constant liquid flow is required to remove hard scale deposits from a system.

Figure 1: Installed *HydroFLOW* unit (Model 160i) at a wastewater treatment plant

A single *HydroFLOW* unit (Model 160i) was installed on the six-inch diameter sludge feed line to one of the BFPs at a location less than 100 feet upstream of the evaluated BFP. Following the installation, an

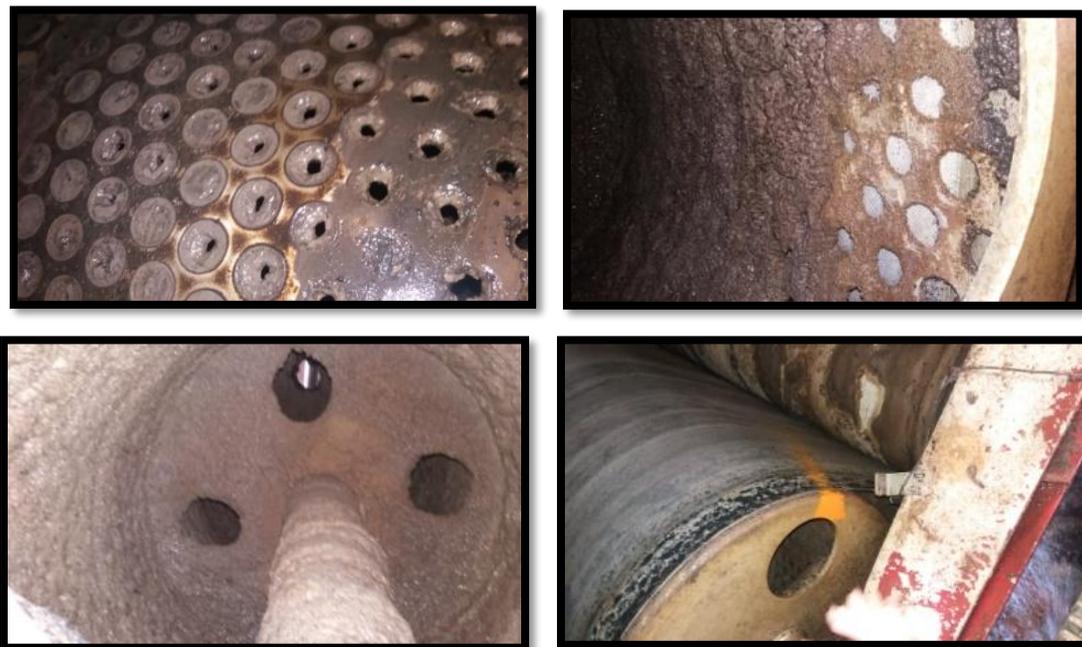
Before energizing the *HydroFLOW* unit, several pictures were taken to establish baseline condition. As shown in the Figure 4 below, heavy struvite encrustation was evident on the drum surface. Other parts of the BFP also showed struvite scale accumulation.

Figure 4: Baseline condition on 7th September 2017 before *HydroFLOW* was activated

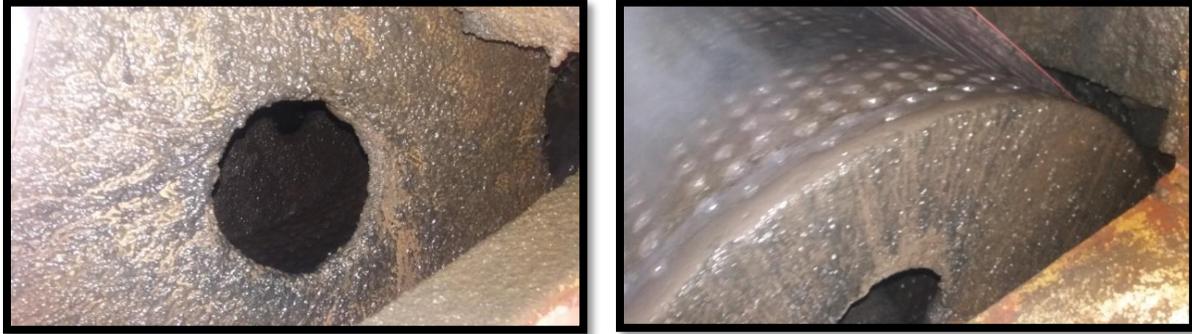
Several pictures, taken on 1st March 2018, were made available for review. These pictures (Figure 5), taken at the end of the 6-month test period, appeared to show softened and reduced scaling.

Figure 5: Final condition on 1st March 2018

One *HydroFLOW* I Range was installed on the sludge feed line to one of the BFPs to evaluate its effectiveness in controlling scaling. The available photographic information and data was insufficient and did not allow a direct comparison between baseline, intermediate, and final observations of scale accumulation. Consequently, it is not possible to solely rely on the provided photographs to make definitive conclusions.

However, following the installation of *HydroFLOW* and discontinuation of anti-scalant, existing scale became soft and was easily removed by spraying with high pressure water. The observations of the plant operating staff at the WPCP are consistent with findings at other facilities where *HydroFLOW* has been tested.
