HydroFLOW Case Study

Scale Reduction - Private Dental Practice, U.S.A.

January 2022

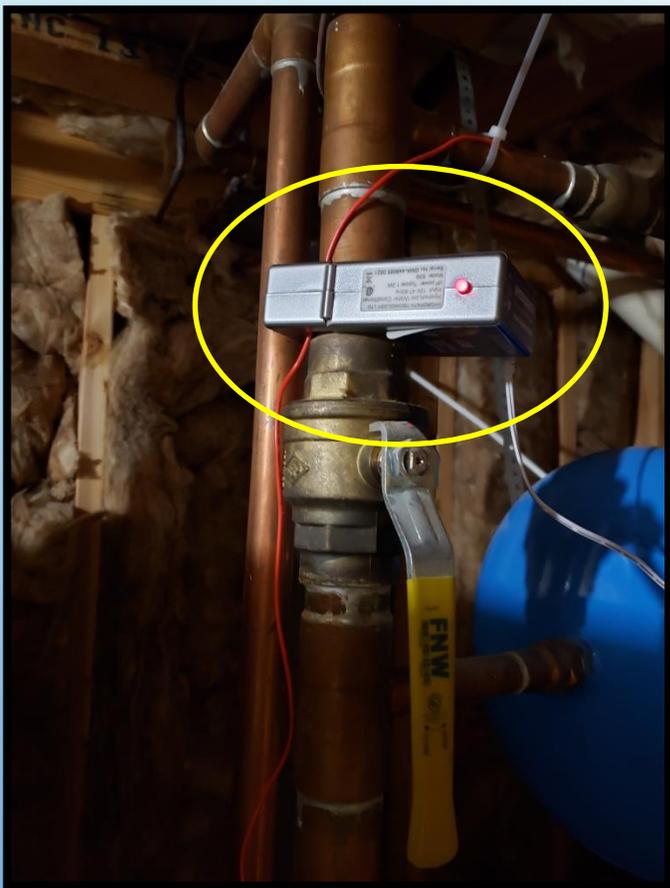
s38 on cold water line to the water heater

- 1 x *hs40* installed on the 1.5" incoming water line.
- 1 x *s38* installed on the 1" cold water line entering the hot water tank.
- 1 x *s38* installed on 1" the cold water line running beneath the kitchen.
- 1 x *s38* installed on the 1" cold water line running beneath procedure room 5.

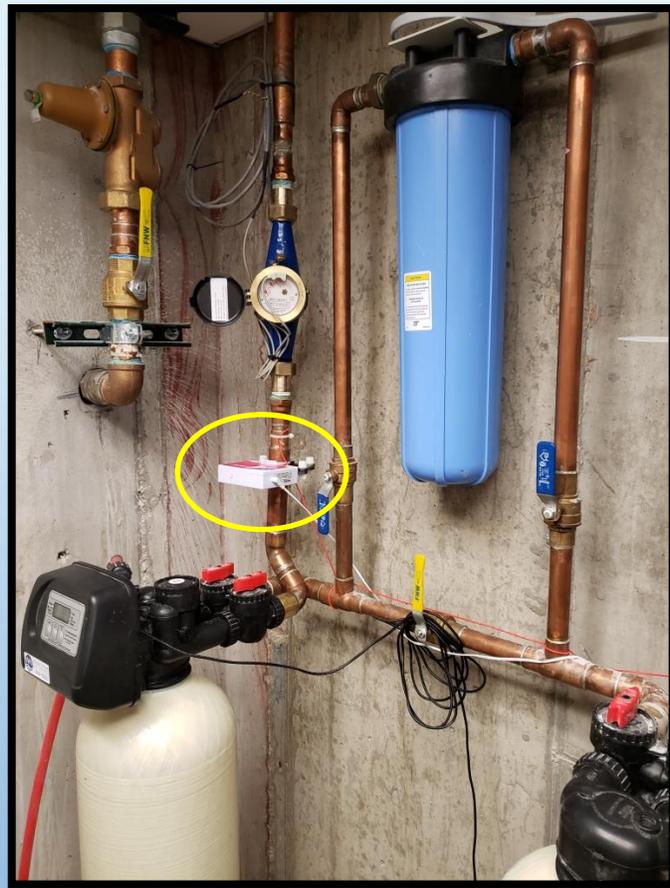
hs40 on incoming water line before filtration

Note: In order to ensure Hydropath signal propagation past the filter, a jumper wire was used to boost the signal past the filter.

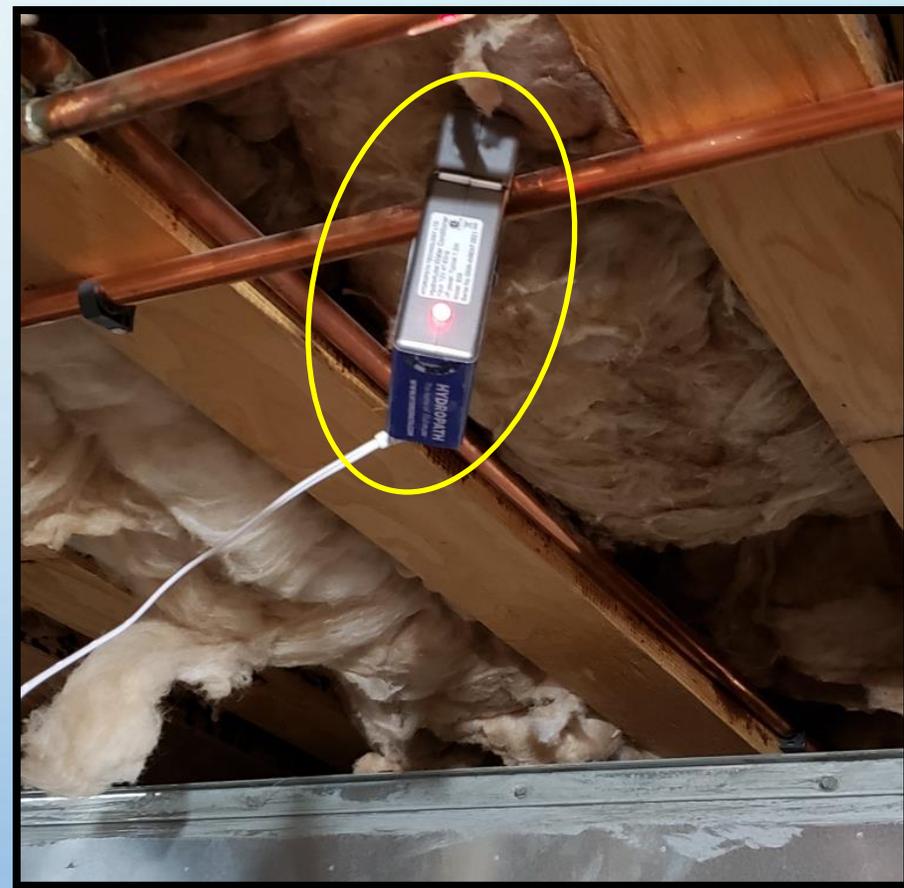
s38 on cold water line beneath the kitchen

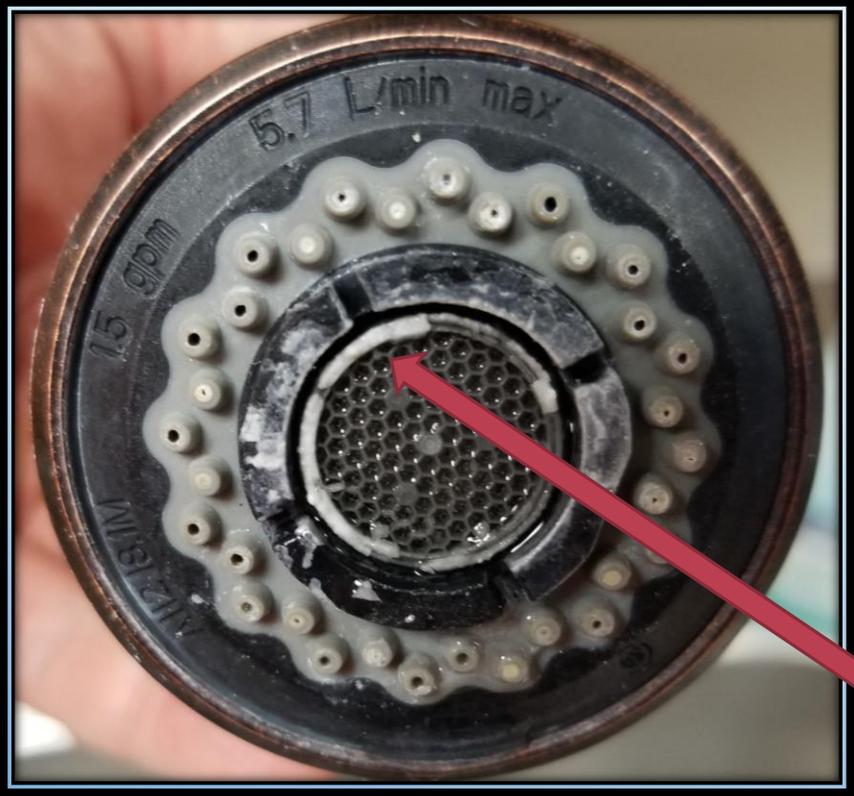
Baseline

Results - Lab Faucet

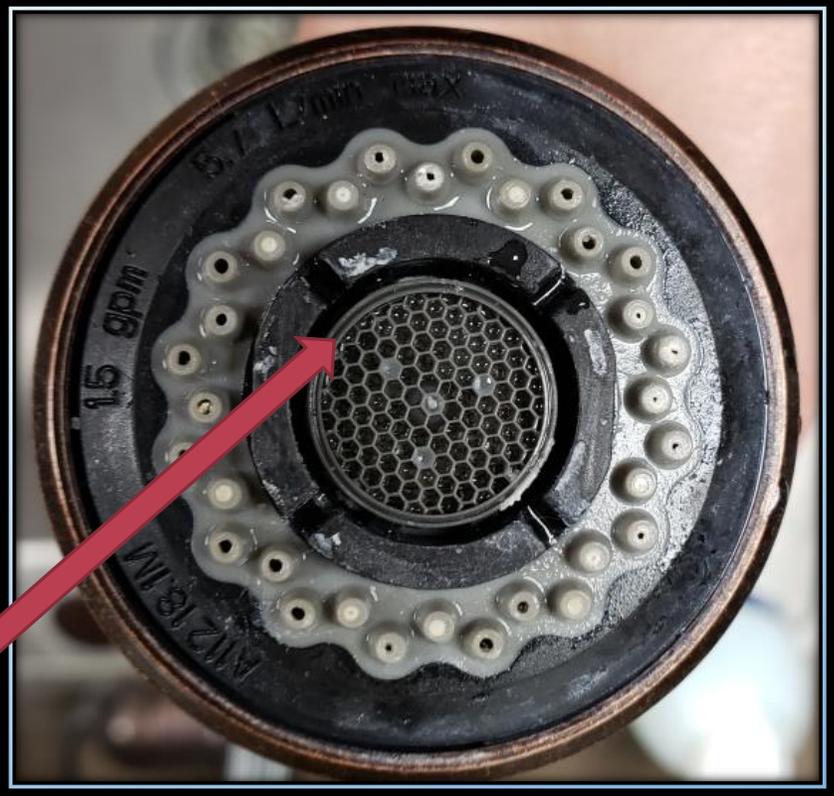
Week 8

Note scale removal without manual cleaning

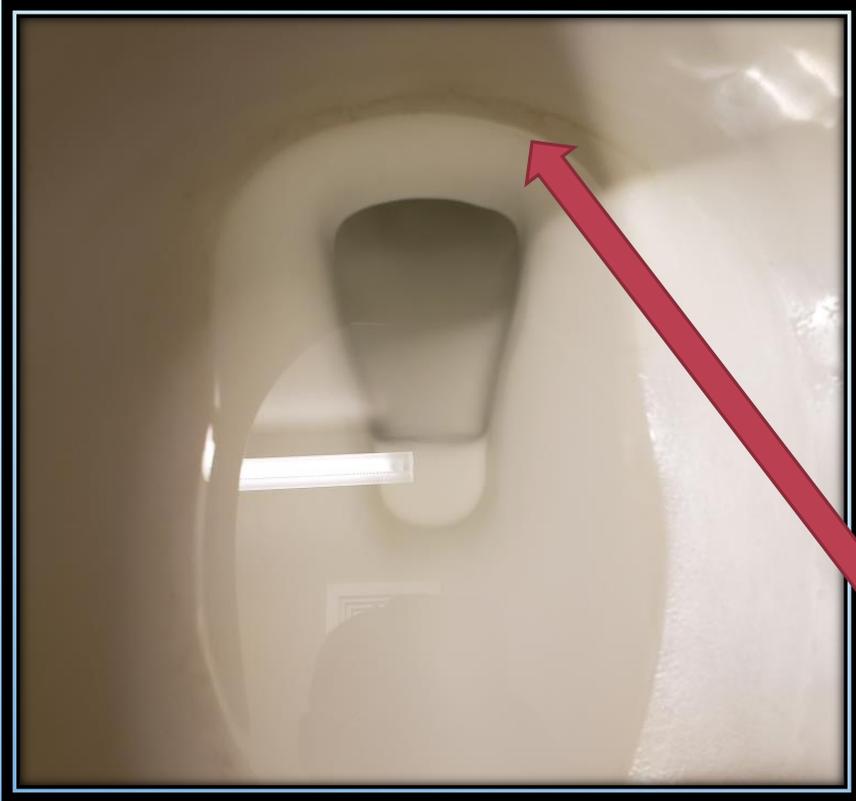
Baseline

Results - Toilet

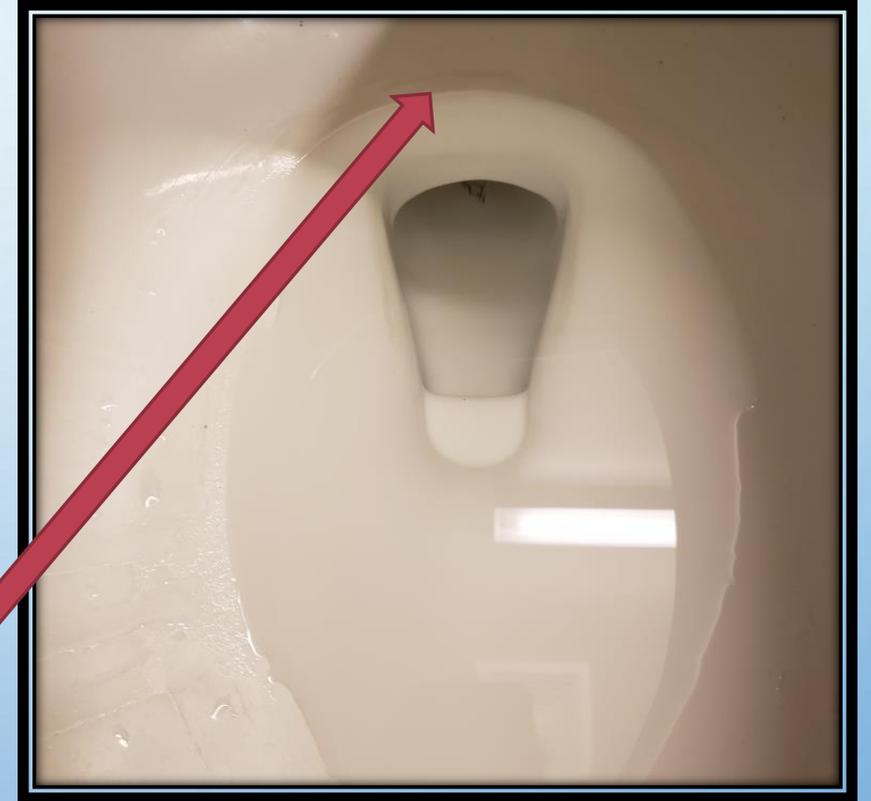
Week 8

Note scale
removal without
manual cleaning

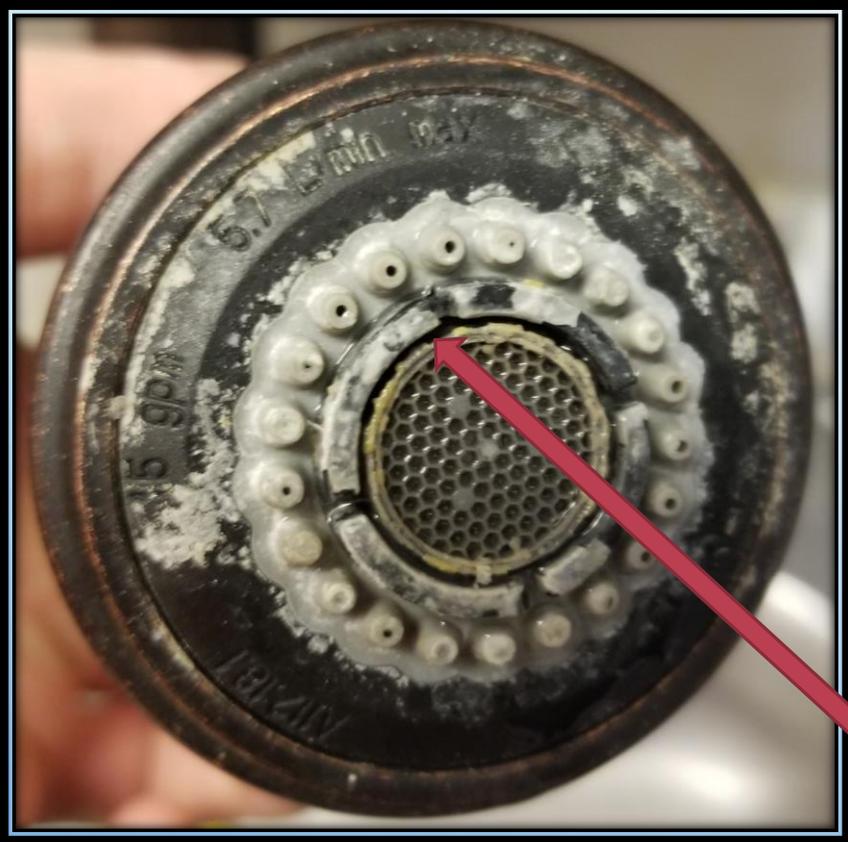
Baseline

Results - Kitchen Faucet

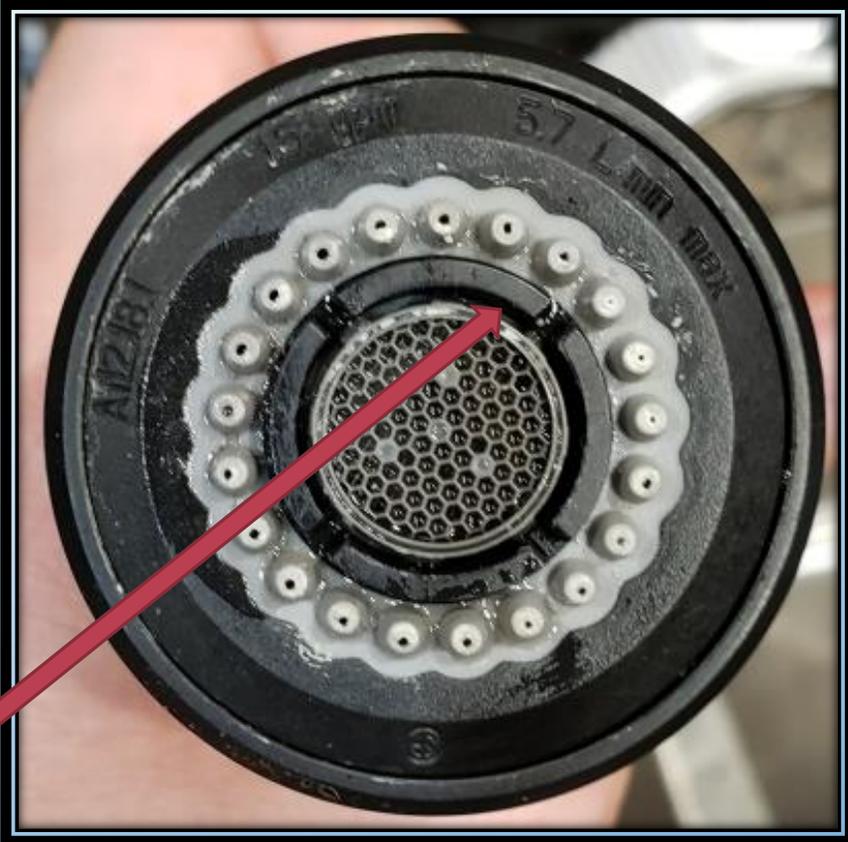
Week 8

Note scale
removal without
manual cleaning

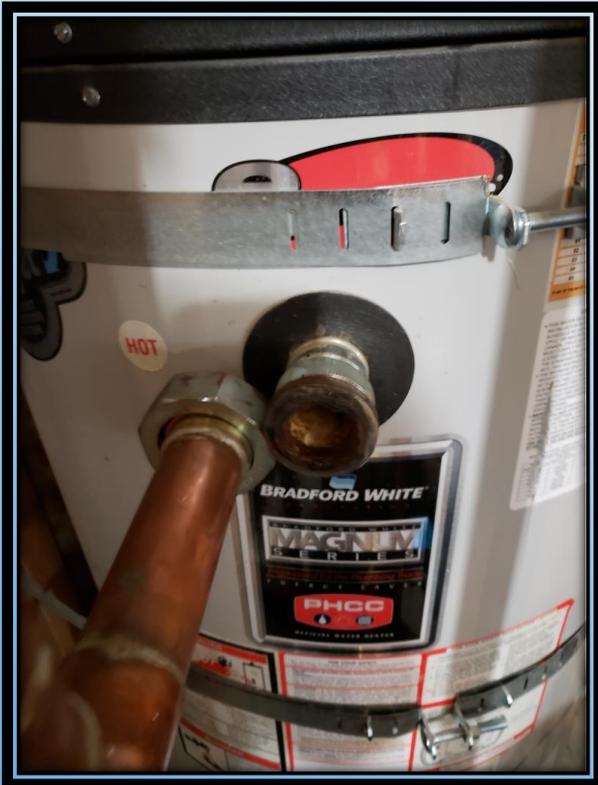
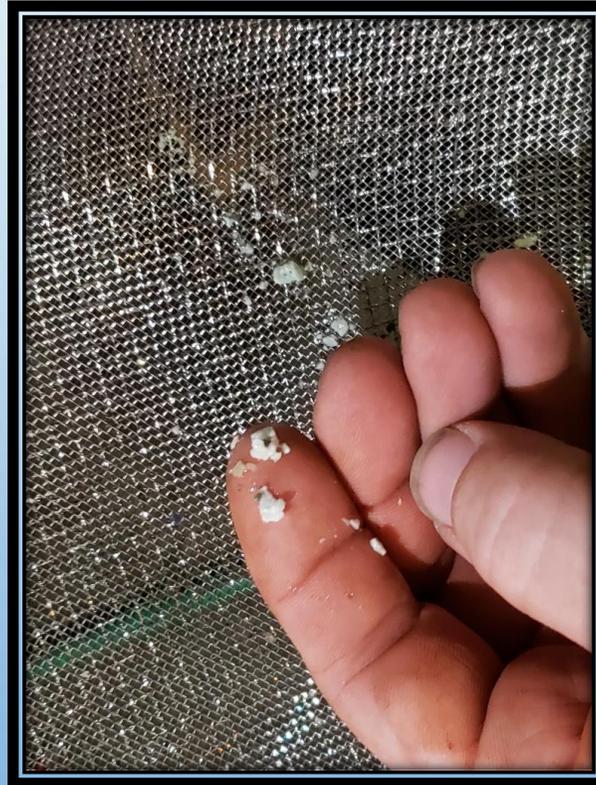
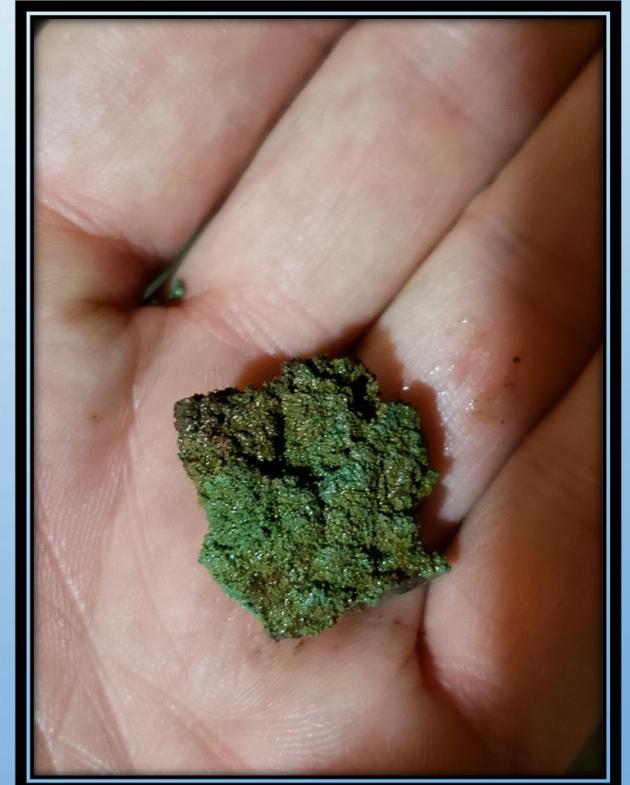
Results - Water Heater

A local plumbing contractor inspected the water heater prior to the installation and 8 weeks after installation. The inspecting plumber provided the following statement after the final examination: “*HydroFLOW* took out years of scale in roughly 2 months. If you install a *HydroFLOW* unit on the cold water pipe feeding your water heater, it will significantly extend its life-cycle.”
