Case Study - Food Processing Cooling Tower - Scale, Bio and Corrosion

(12 month evaluation)

- Location: G & G Orchards Yakima, Washington 98908
- **Application:** BAC Condenser and EVAPCO Condenser which feeding into a common sump tank.
- **Unit**: *Hydro*FLOW P100 and *Hydro*FLOW P120.
- Purpose:Reduce limescale accumulation, biological growth and corrosion while
eliminating the need for descalant, biocide and anti-corrosive chemicals.
- Install date:September 20, 2011 P100 installed on BAC Condenser.March 1, 2012 P120 installed on EVAPCO Condenser.
- **Installed by:** *Hydro*FLOW West Inc.
- **Monitoring:** Conductivity measurements, blow-down frequencies, chemical usage and photo documentation.

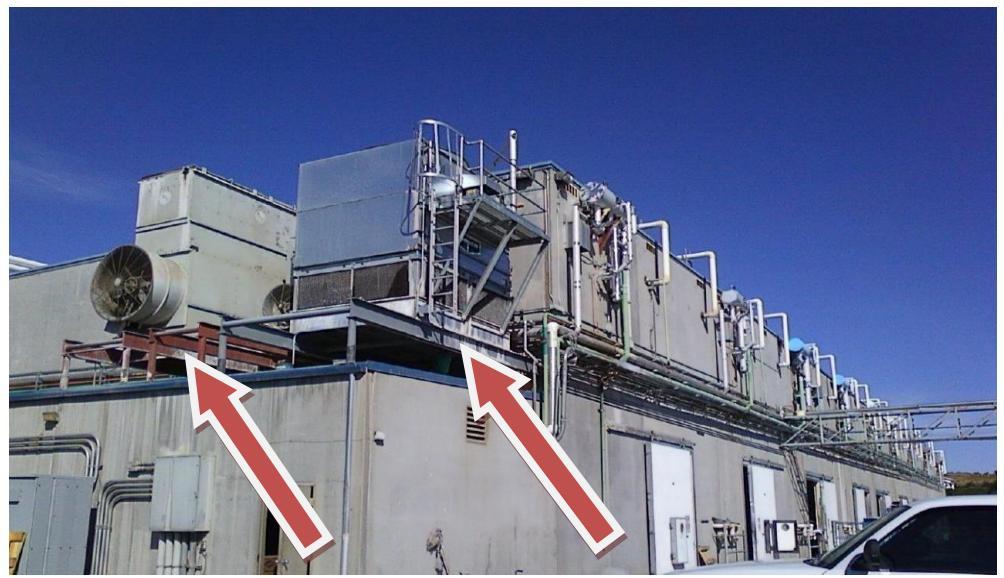
BAC Condenser

EVAPCO Condenser

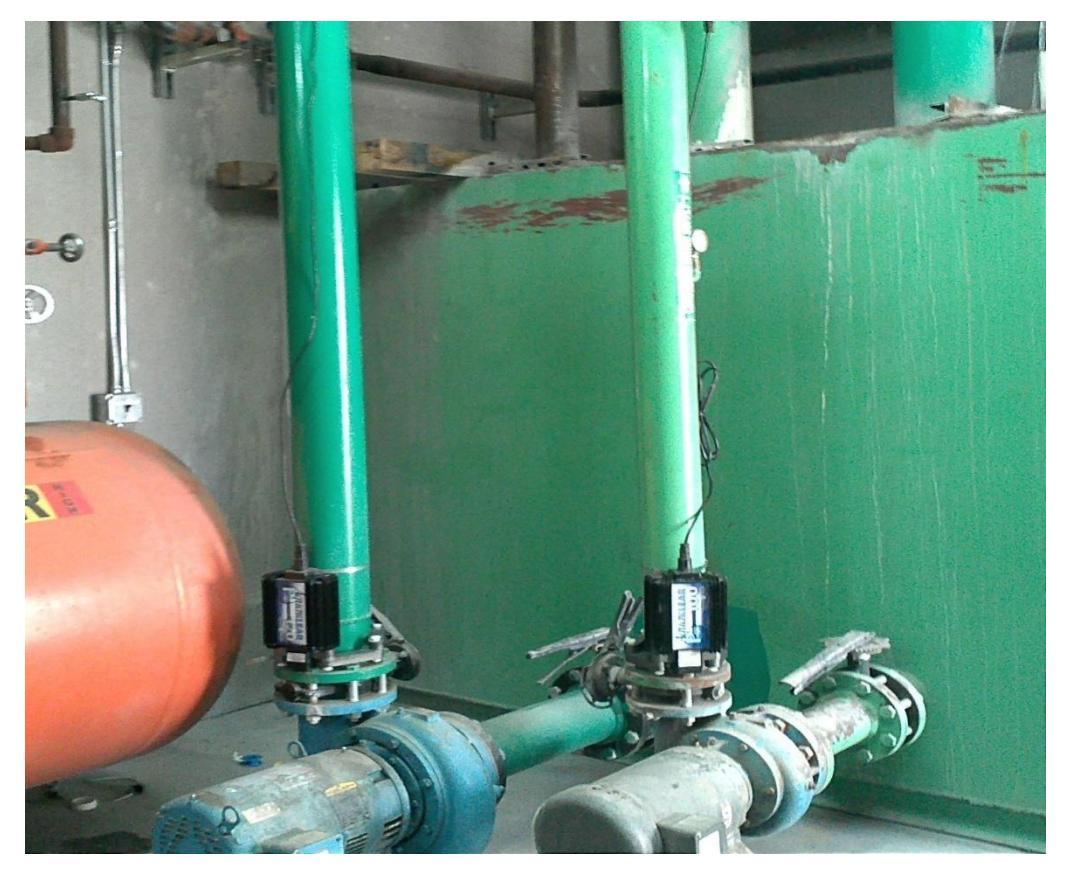
Installation Location

HydroFLOW P120 and P100 devices installed at the discharge from sump tank

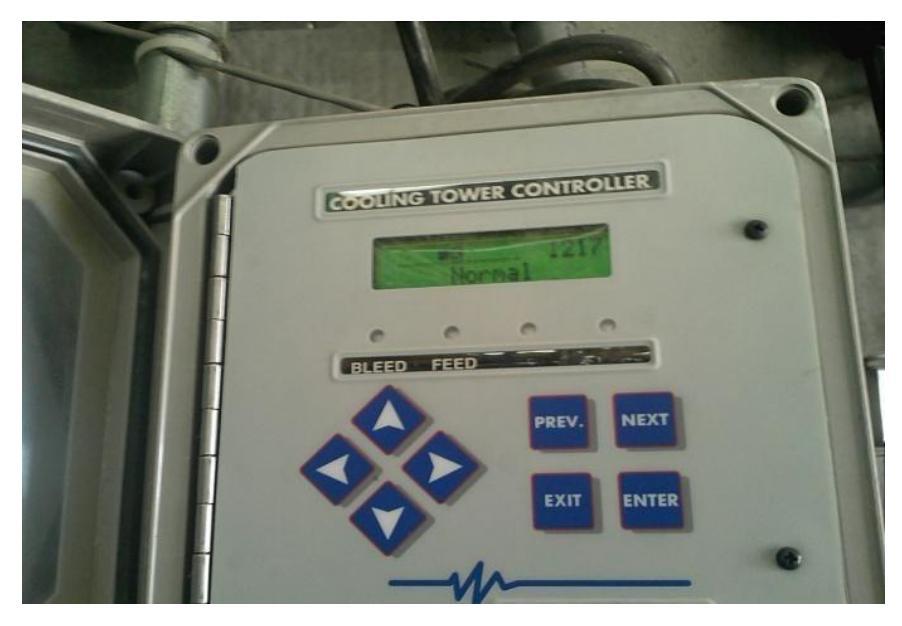
Conductivity Meter

With minimal blow-down, conductivity was maintained under 1,600 $\mbox{$\muS}$ throughout the 12 month evaluation period.

Date	Conductivity	Chem. usage	Blow-down
9/20/11 (BAC Installation)	1,245 μS	Yes	Less than once a month
10/27/11	1,580 µS	Yes	Less than once a month
11/11/11	984 μS	No	Less than once a month
12/7/11	1,108 µS	No	Less than once a month
1/27/12	914 μS	No	Less than once a month
3/1/12 (EVAPCO Installation)	1,082 μS	No	Less than once a month
7/11/12	1,054 μS	No	Less than once a month
8/14/12	1,287 μS	No	Less than once a month
9/28/12	890 μS	No	Less than once a month

Table 1 - Data collected from sump tank

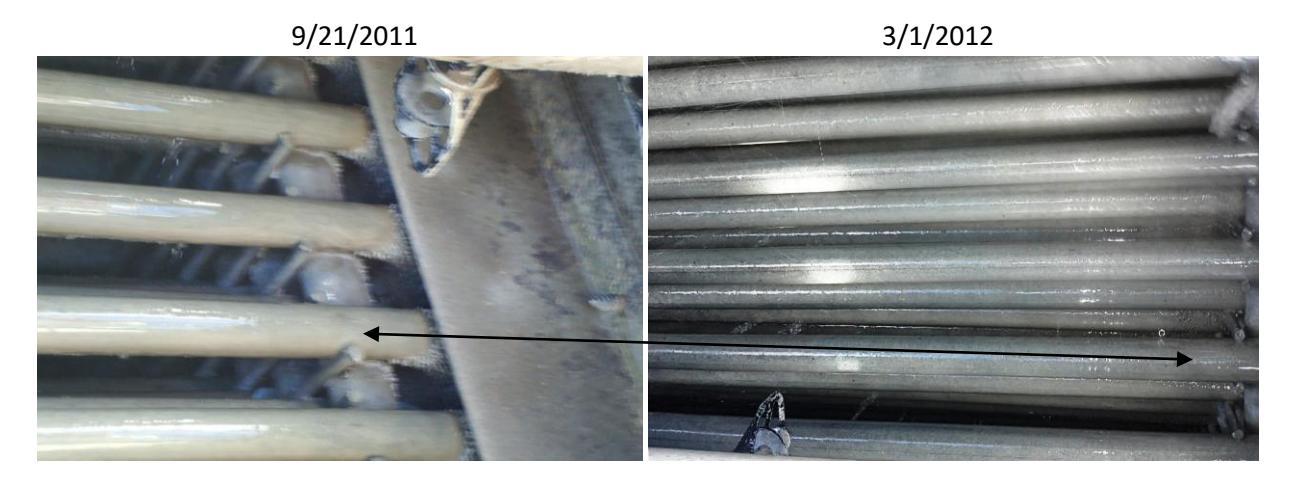
BAC Condenser - Heat exchange tubes

With chemicals - 1/8'' of hard scale. which wipes off easily.

Without chemicals - 1/32" of 'soft scale'

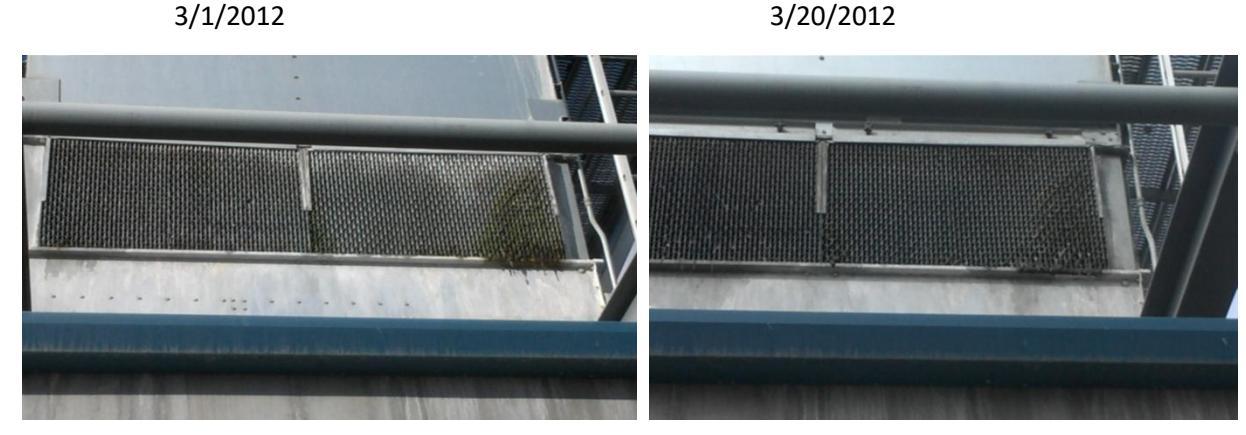
EVAPCO Condenser - Fins

Installation date of P120 device - Scale

accumulation and bio growth is evident.

9/20/2012 (Chemically treated)

3 weeks later - Scale is gone and bio

growth is being eradicated.

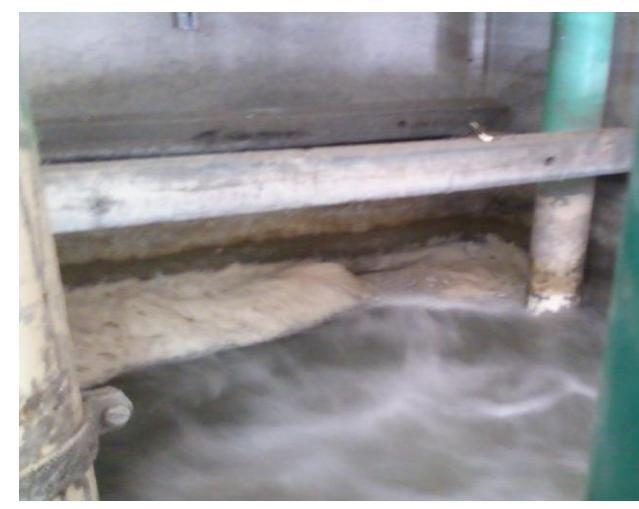
Sump Tank

Scum, bio growth and corrosion are evident.

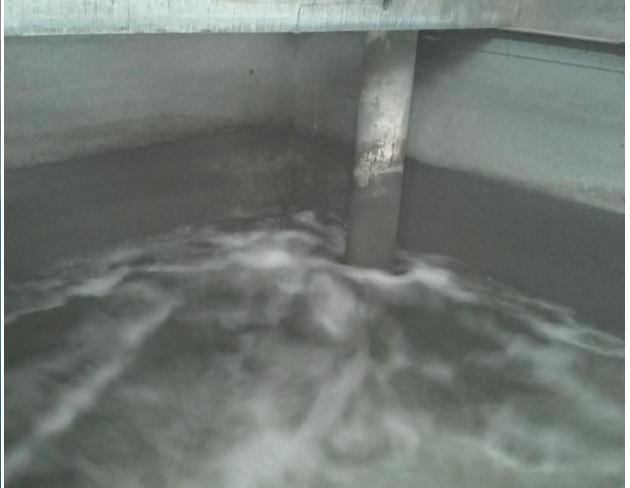
8/14/2012 (9 months Chemical free).

Scum, bio growth and corrosion are no longer an issue. A protective layer of magnetite has formed in place of the corrosion.
