## **MV Hoegh America - Proof of Concept Experiment - Final Report**

The use of a HydroPath MARINE system on a fresh water generator unit

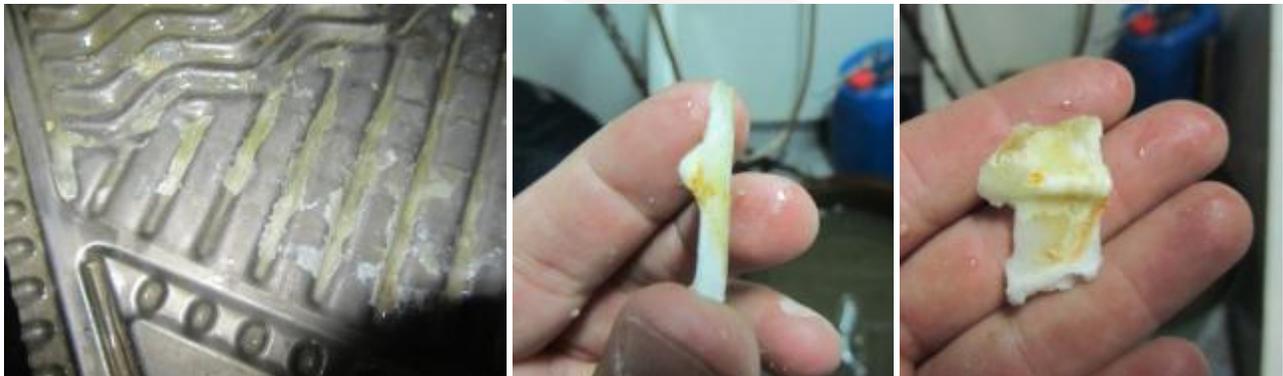
On the day of installation, the FWG was opened, although its indicator did not show any reduction of water production. Last opening and cleaning was conducted during May 2012. The FWG was treated with chemicals (Liquidewt) on a regular basis by a dosing pump, as instructed by the ship managers. Despite that, on most plates of the heat exchanger it was found that there was a buildup of lime scale which was up to 3 mm thick (figure 2).

**Figure 2.** Lime scale precipitation on the titanium heat exchanger plates prior to the installation.

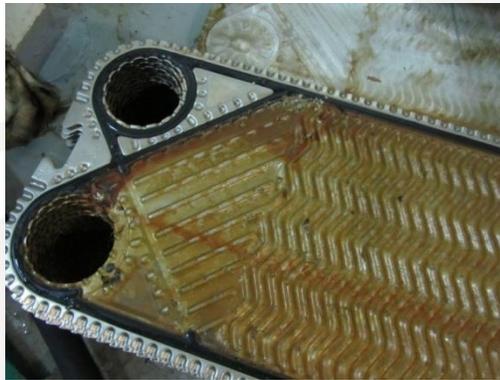
**Figure 3.** FWG plates covered with slime.

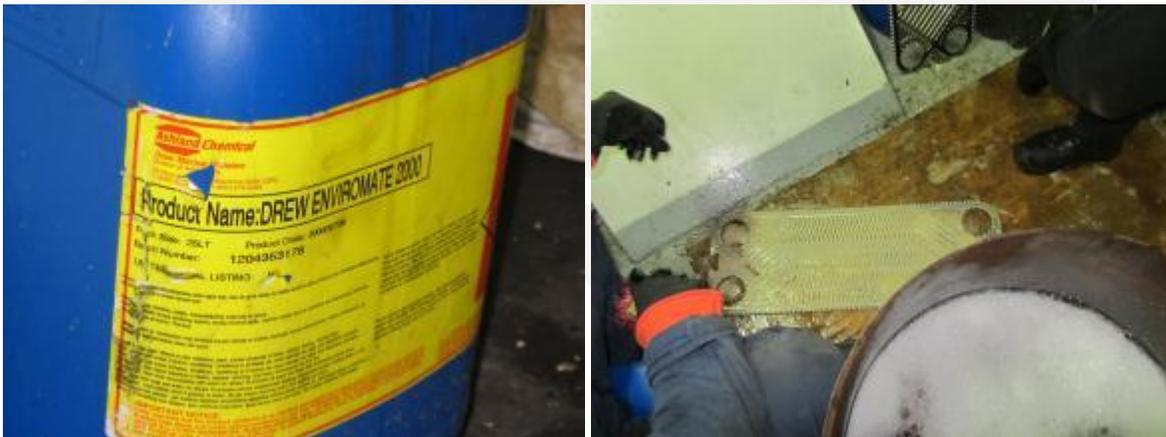
1. Plates are dipped in a chemical (Drew Enviromate 2000) and brushed to remove soft dirt and slime (figure 4).
2. Plates are dipped in a chemical (Liquidewt) to soften the lime scale, which is later carved out with a sharp ended tool made of a copper pipe (figure 5).

**Figure 4.** Left: Drew Enviromate 2000 - multipurpose cleaning. Right: Plate is brushed to remove deposits.

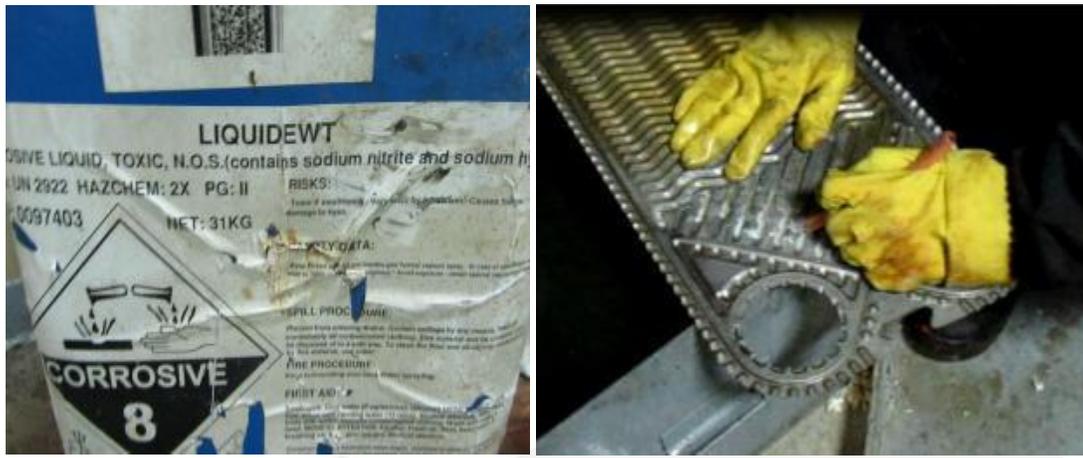
**Figure 5.** Left: Chemical used to soften lime scale. Right: Carving out lime scale.

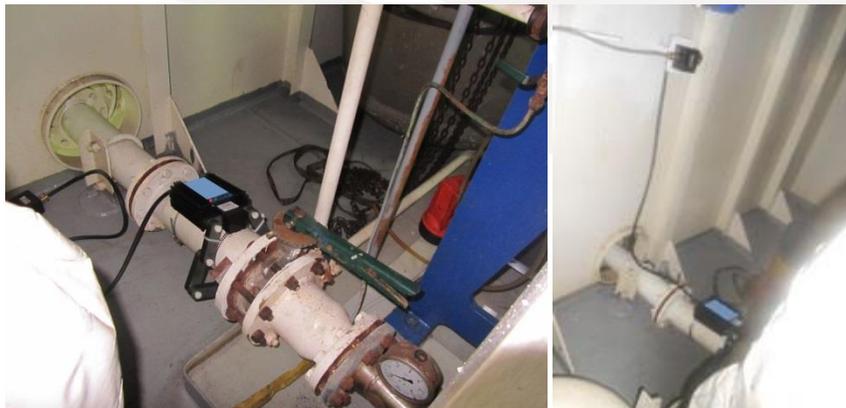
The HydroPath MARINE system was installed on a 4" pipe, providing sea water to the FWG approximately 1 meter before the inlet to the FWG. The system was installed slightly backwards from where it should have been placed, in order to protect it from wetness whilst opening the FWG. The system is connected to an EJB connection / junction box as seen on figure 6. The EJB connection / junction box is connected to the main power cabinet of the FWG (see figure 7).

**Figure 6.** Left: System installation location. Right: System connected to an EJB connection.

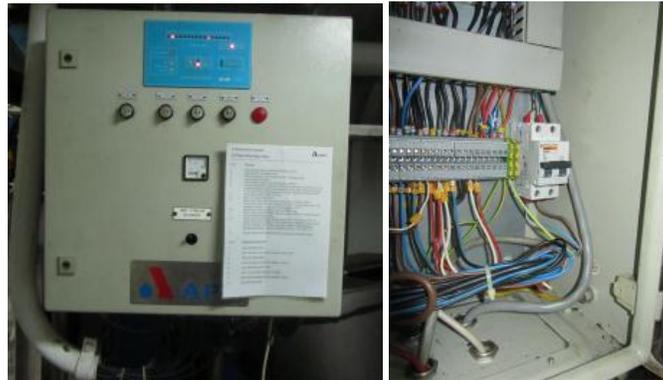
**Figure 7.** FWG main power cabinet and cable connection.

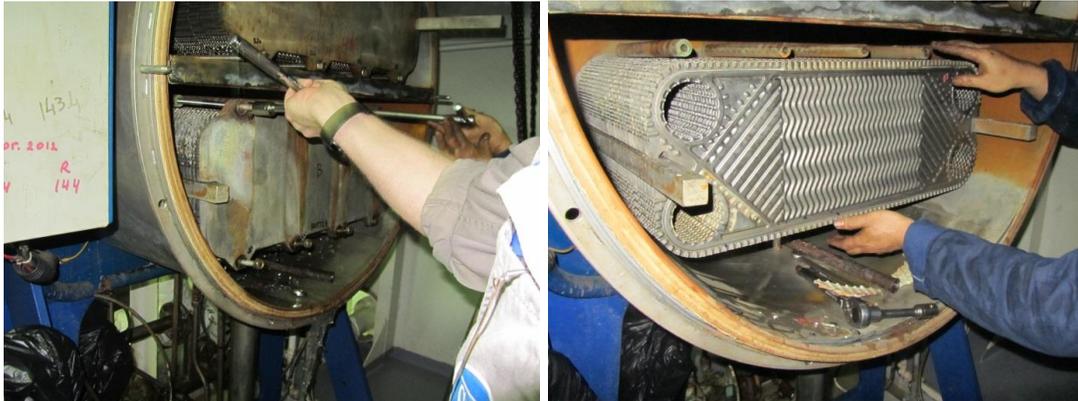
3. When the FWG cover was first opened, the water released was very clear with no mud or signs of murkiness.
4. Most of the plates were found clean and had no lime scale built up on them. On several plates, there were areas with very loose lime scale buildup, which was easily removed with a gentle hand touch or shake-off of the plate and without any chemicals or carving process (as seen in figure 9).

**Figure 8.** FWG is opened and cover is removed. Water released is clear.

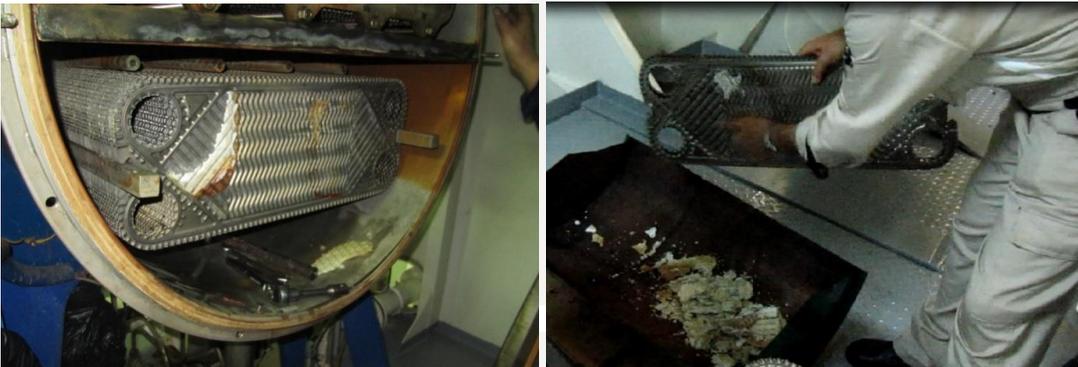
**Figure 9.** Some plates had limescale on them, but it was easily removed by hand.

3. Most of the plates were perfectly clean. A few plates had areas of lime scale buildup on them, with a certain pattern (see explanation below). This lime scale was very loose and was easily and smoothly removed by a hand.

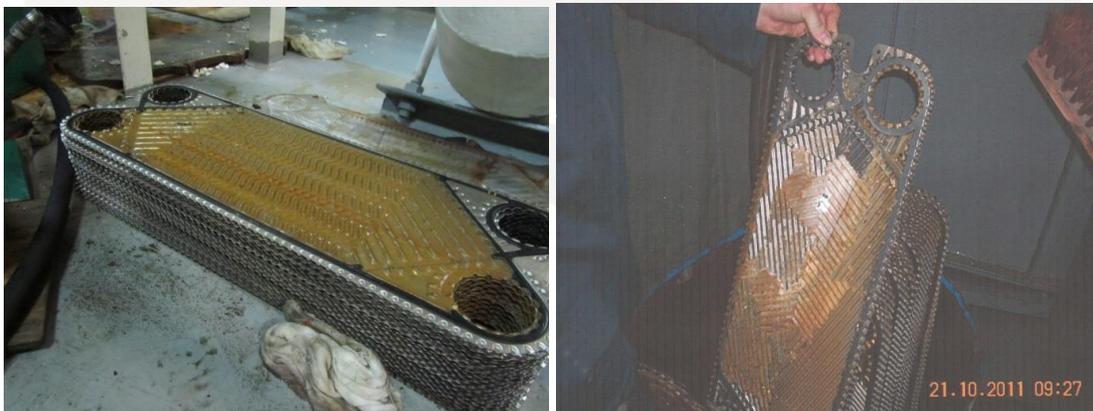
**Figure 10.** Left: December 2012 - before installation, plates are covered with slime. Right: FWG plates (different FWG unit) treated with chemicals but covered with lime scale and slime.

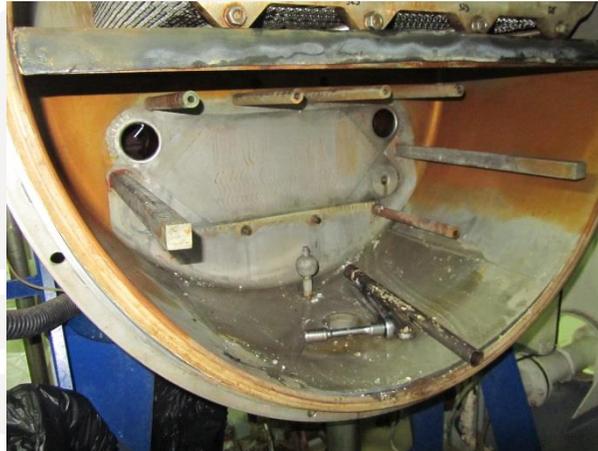
**Figure 12.** June 2013 - FWG chamber (where plates are mounted) treated with a HydroPath MARINE system, without any lime scale or slime.

4. The part of the chamber where the plates were mounted was absolutely clean. The part that was not in contact with the treated water was found with a thin layer of scale.
