## **MV Hoegh America - Proof of Concept Experiment - Final Report**

The use of a HydroPath MARINE system on a fresh water generator unit

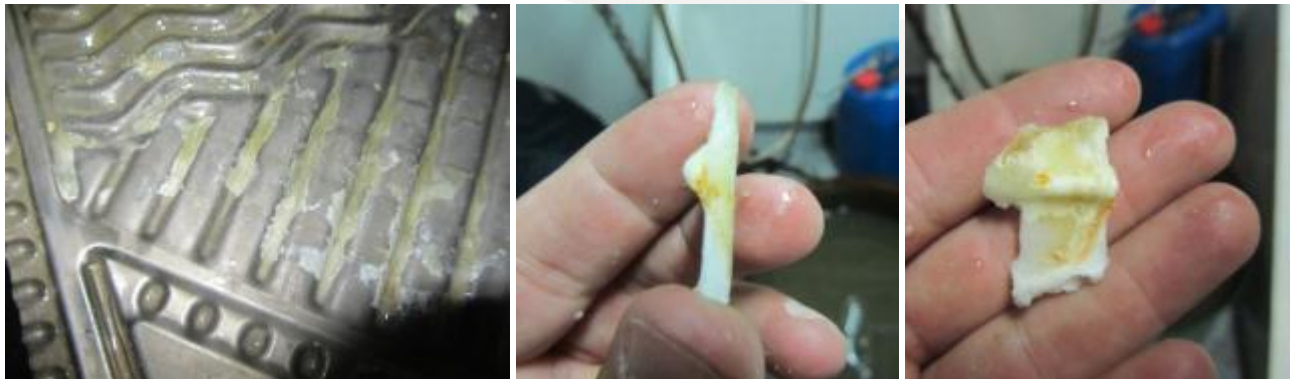
**Figure 2.** Lime scale precipitation on the titanium heat exchanger plates prior to the installation.

On the day of installation, the FWG was opened, although its indicator did not show any reduction of water production. Last opening and cleaning was conducted during May 2012. The FWG was treated with chemicals (Liquidewt) on a regular basis by a dosing pump, as instructed by the ship managers. Despite that, on most plates of the heat exchanger it was found that there was a buildup of lime scale which was up to 3 mm thick (figure 2).

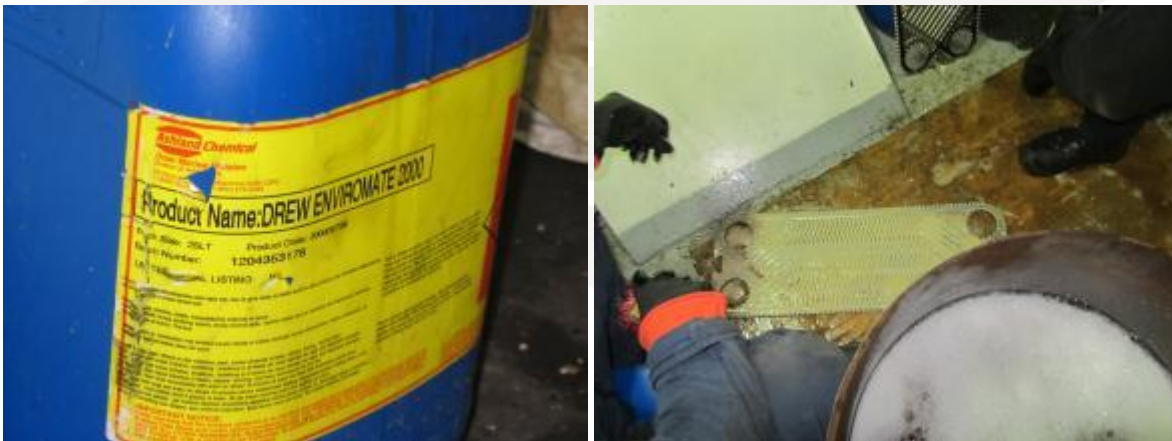
**Figure 4.** Left: Drew Enviromate 2000 - multipurpose cleaning. Right: Plate is brushed to remove deposits.

1. Plates are dipped in a chemical (Drew Enviromate 2000) and brushed to remove soft dirt and slime (figure 4).
2. Plates are dipped in a chemical (Liquidewt) to soften the lime scale, which is later carved out with a sharp ended tool made of a copper pipe (figure 5).

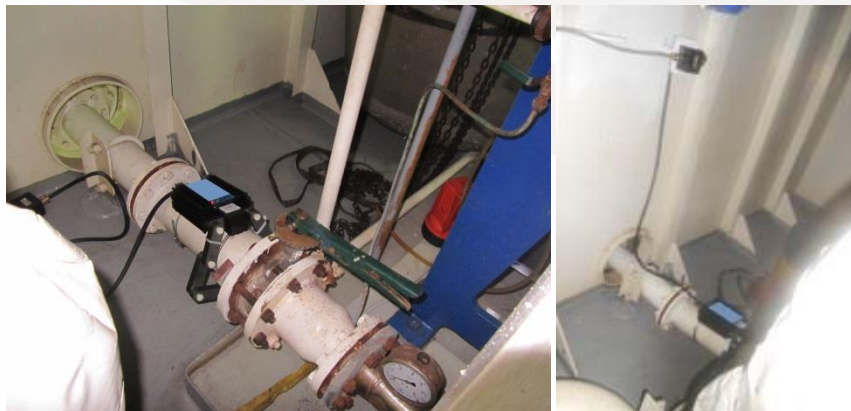
**Figure 6.** Left: System installation location. Right: System connected to an EJB connection.

The HydroPath MARINE system was installed on a 4" pipe, providing sea water to the FWG approximately 1 meter before the inlet to the FWG. The system was installed slightly backwards from where it should have been placed, in order to protect it from wetness whilst opening the FWG. The system is connected to an EJB connection / junction box as seen on figure 6. The EJB connection / junction box is connected to the main power cabinet of the FWG (see figure 7).

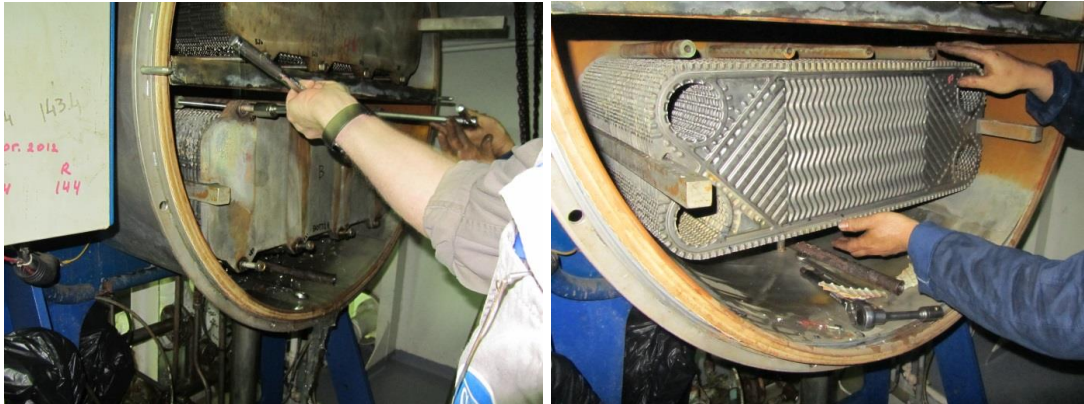
**Figure 8.** FWG is opened and cover is removed. Water released is clear.

3. When the FWG cover was first opened, the water released was very clear with no mud or signs of murkiness.
4. Most of the plates were found clean and had no lime scale built up on them. On several plates, there were areas with very loose lime scale buildup, which was easily removed with a gentle hand touch or shake-off of the plate and without any chemicals or carving process (as seen in figure 9).

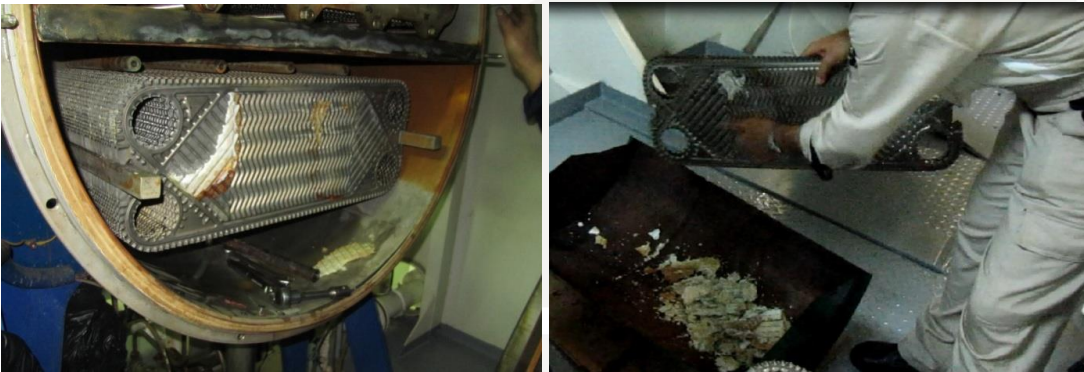
**Figure 9.** Some plates had limescale on them, but it was easily removed by hand.

3. Most of the plates were perfectly clean. A few plates had areas of lime scale buildup on them, with a certain pattern (see explanation below). This lime scale was very loose and was easily and smoothly removed by a hand.

The presence of lime scale on several of the plates is a temporary phenomenon which can be explained as follows:

1. It should be recognized that the HydroPath MARINE system emits a high frequency signal that travels back and forth within the water pipe. Bearing in mind that the experiment took place on a vessel nearing its 10<sup>th</sup> year of operation, the sea water inlet pipe, leading to the FWG, had already accumulated a considerable buildup of lime scale on the pipe's inner surface. The HydroPath MARINE system, through the emitted pulses, affects the existing lime scale on the inner pipe by breaking it off over time. The broken lime scale pieces traveled with the water stream towards the plates and accumulated there. This can be seen in several photos showing a distinct water flow pattern on the lime scale pieces. This is a very common phenomenon and it can be said with much confidence that had the experiment continued for another month or two, the remaining lime scale would have been also dissolved as a result of the HydroPath MARINE system and thus would have been washed away with the water stream.

2. An additional point to consider is that this particular FWG has been in operation for over 10 years. The titanium plates which would typically have a very smooth surface were full of scratches and uneven surfaces due to years of harsh cleaning. The un-even surface of the plates renders them increasingly susceptible to lime scale accumulation.

3. Another, but not less important, issue is the difference between conditioned water (i.e. water which was exposed to the high frequency signal the HydroPath MARINE system emits) and unconditioned water. When water is treated with the HydroPath MARINE system, the mineral ions (dissolved solids) are clustered and shortly thereafter crystalized when exposed to heat and/or pressure change (i.e. the minerals precipitate out of solution and convert into suspended mineral crystals). This crystallization process prevents the minerals from attaching to the plates as hard scale, and therefore, the minuscule scale buildup can be easily removed from the surface of the plate.

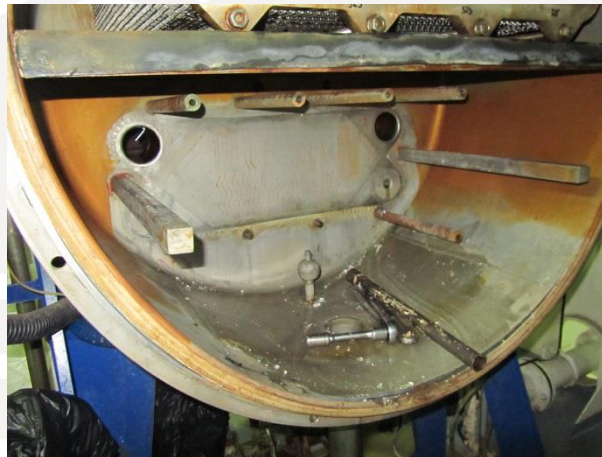
**Figure 12.** June 2013 - FWG chamber (where plates are mounted) treated with a HydroPath MARINE system, without any lime scale or slime.

5. The FWG chamber on the sea water side was also clean and contained no lime scale, mud or slime.
6. The entire opening, cleaning and closing process took slightly less than two hours (instead of 24-48 hours).

4. The part of the chamber where the plates were mounted was absolutely clean. The part that was not in contact with the treated water was found with a thin layer of scale.
