Cooling Tower & Chiller Plant Case Studies

The Benefits of HydroFLOW

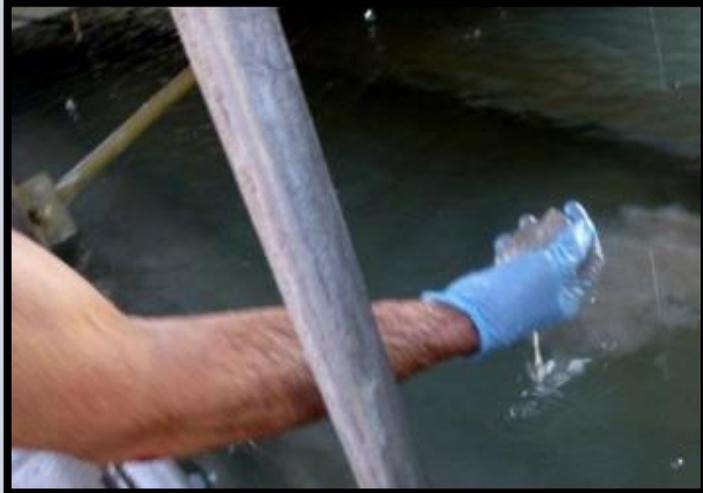
As minerals precipitates out of solution as fine powder, they can be filtered out, saving bleed/blow-down water consumption.

Loose mineral deposits collected in the sump, instead of inside pipes and equipment as hard scale.

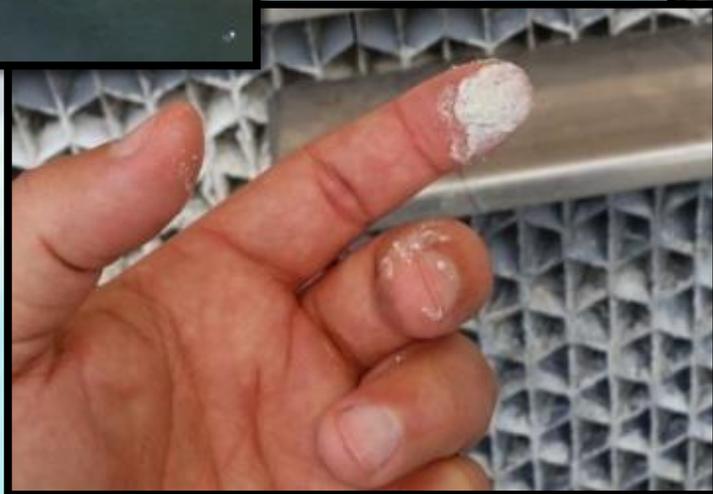
Drift eliminator before.

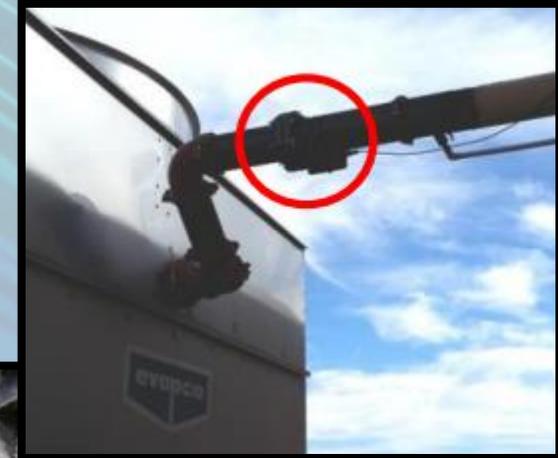
Installed *HydroFLOW* device.

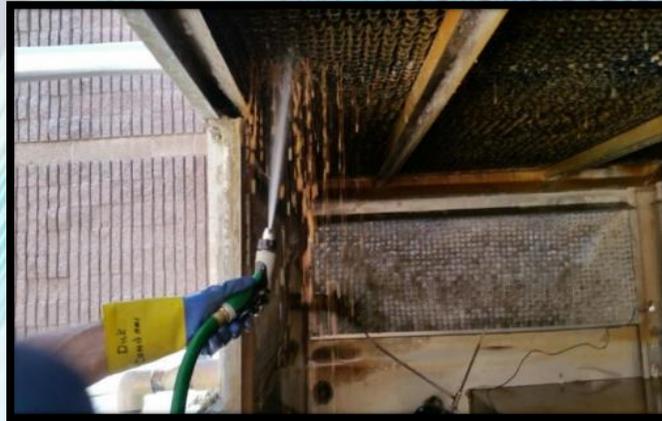
Instead of the hard scale that typically accumulates inside the cooling tower, loose brown mud-like material was found. A garden hose was used to easily remove the mud-like substance from the fill material and the drift eliminators.
