CASE STUDY – STEEL MILL ONTARIO, CANADA

GALVANIZING LINE SPRAY BAR

A HYDROFLOW CANADA PROJECT

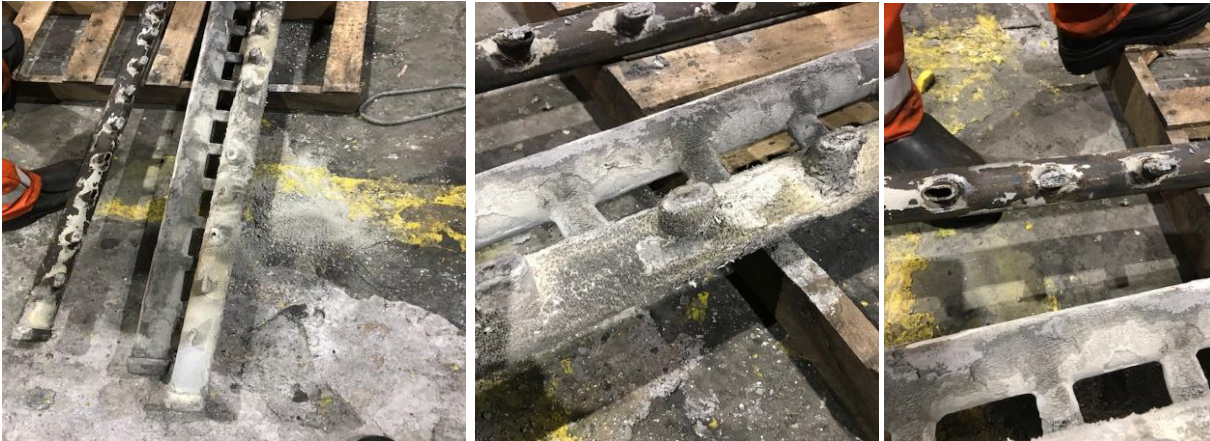
PHOTOGRAPH OF PROBLEM AREA BEFORE TREATMENT

- High Concentration of TDS and contaminants causing complete blockage, the (6) Spray bars would need to be removed and changed out every 3 weeks
- Production schedule would be interrupted due to spray failures, clogging and maintenance.

- Supply piping would become blocked requiring mechanical auguring and high-pressure sprays to remove the buildup and blockages.
- Spray nozzles and bars required mechanical and chemical cleaning using manpower and hazardous chemicals.

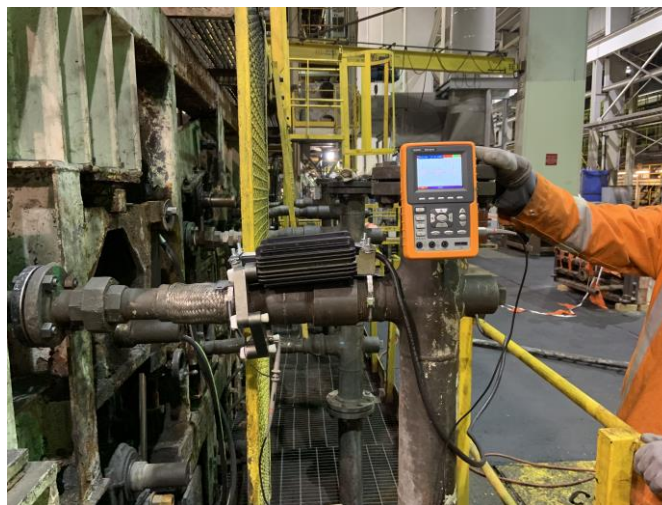
INSTALLATION POINT

- Initial Installation shown – In this position the results were limited
- The unit was subsequently moved to the output piping of the system pump

Model of Water Conditioner	<i>HydroFLOW i100 Electronic Water Conditioner</i>
Pipe Diameter(OD)	<i>3" Header to 1 ½" spray nozzles</i>
Pipe Material	<i>Rubber Pipe and Steel Header (Initial install was on steel pipe)</i>
Installation location (before/after pump)	<i>On the Output of the Pump (after)</i>
